LANDSLIDES AND RELATED FEATURES

OF THE PLEASANT SHADE, TENN. QUADRANGLE

Roger E. Thomas and Alfred R. Taylor

U.S. Geological Survey
OPEN FILE MAP 82-653(0-1)

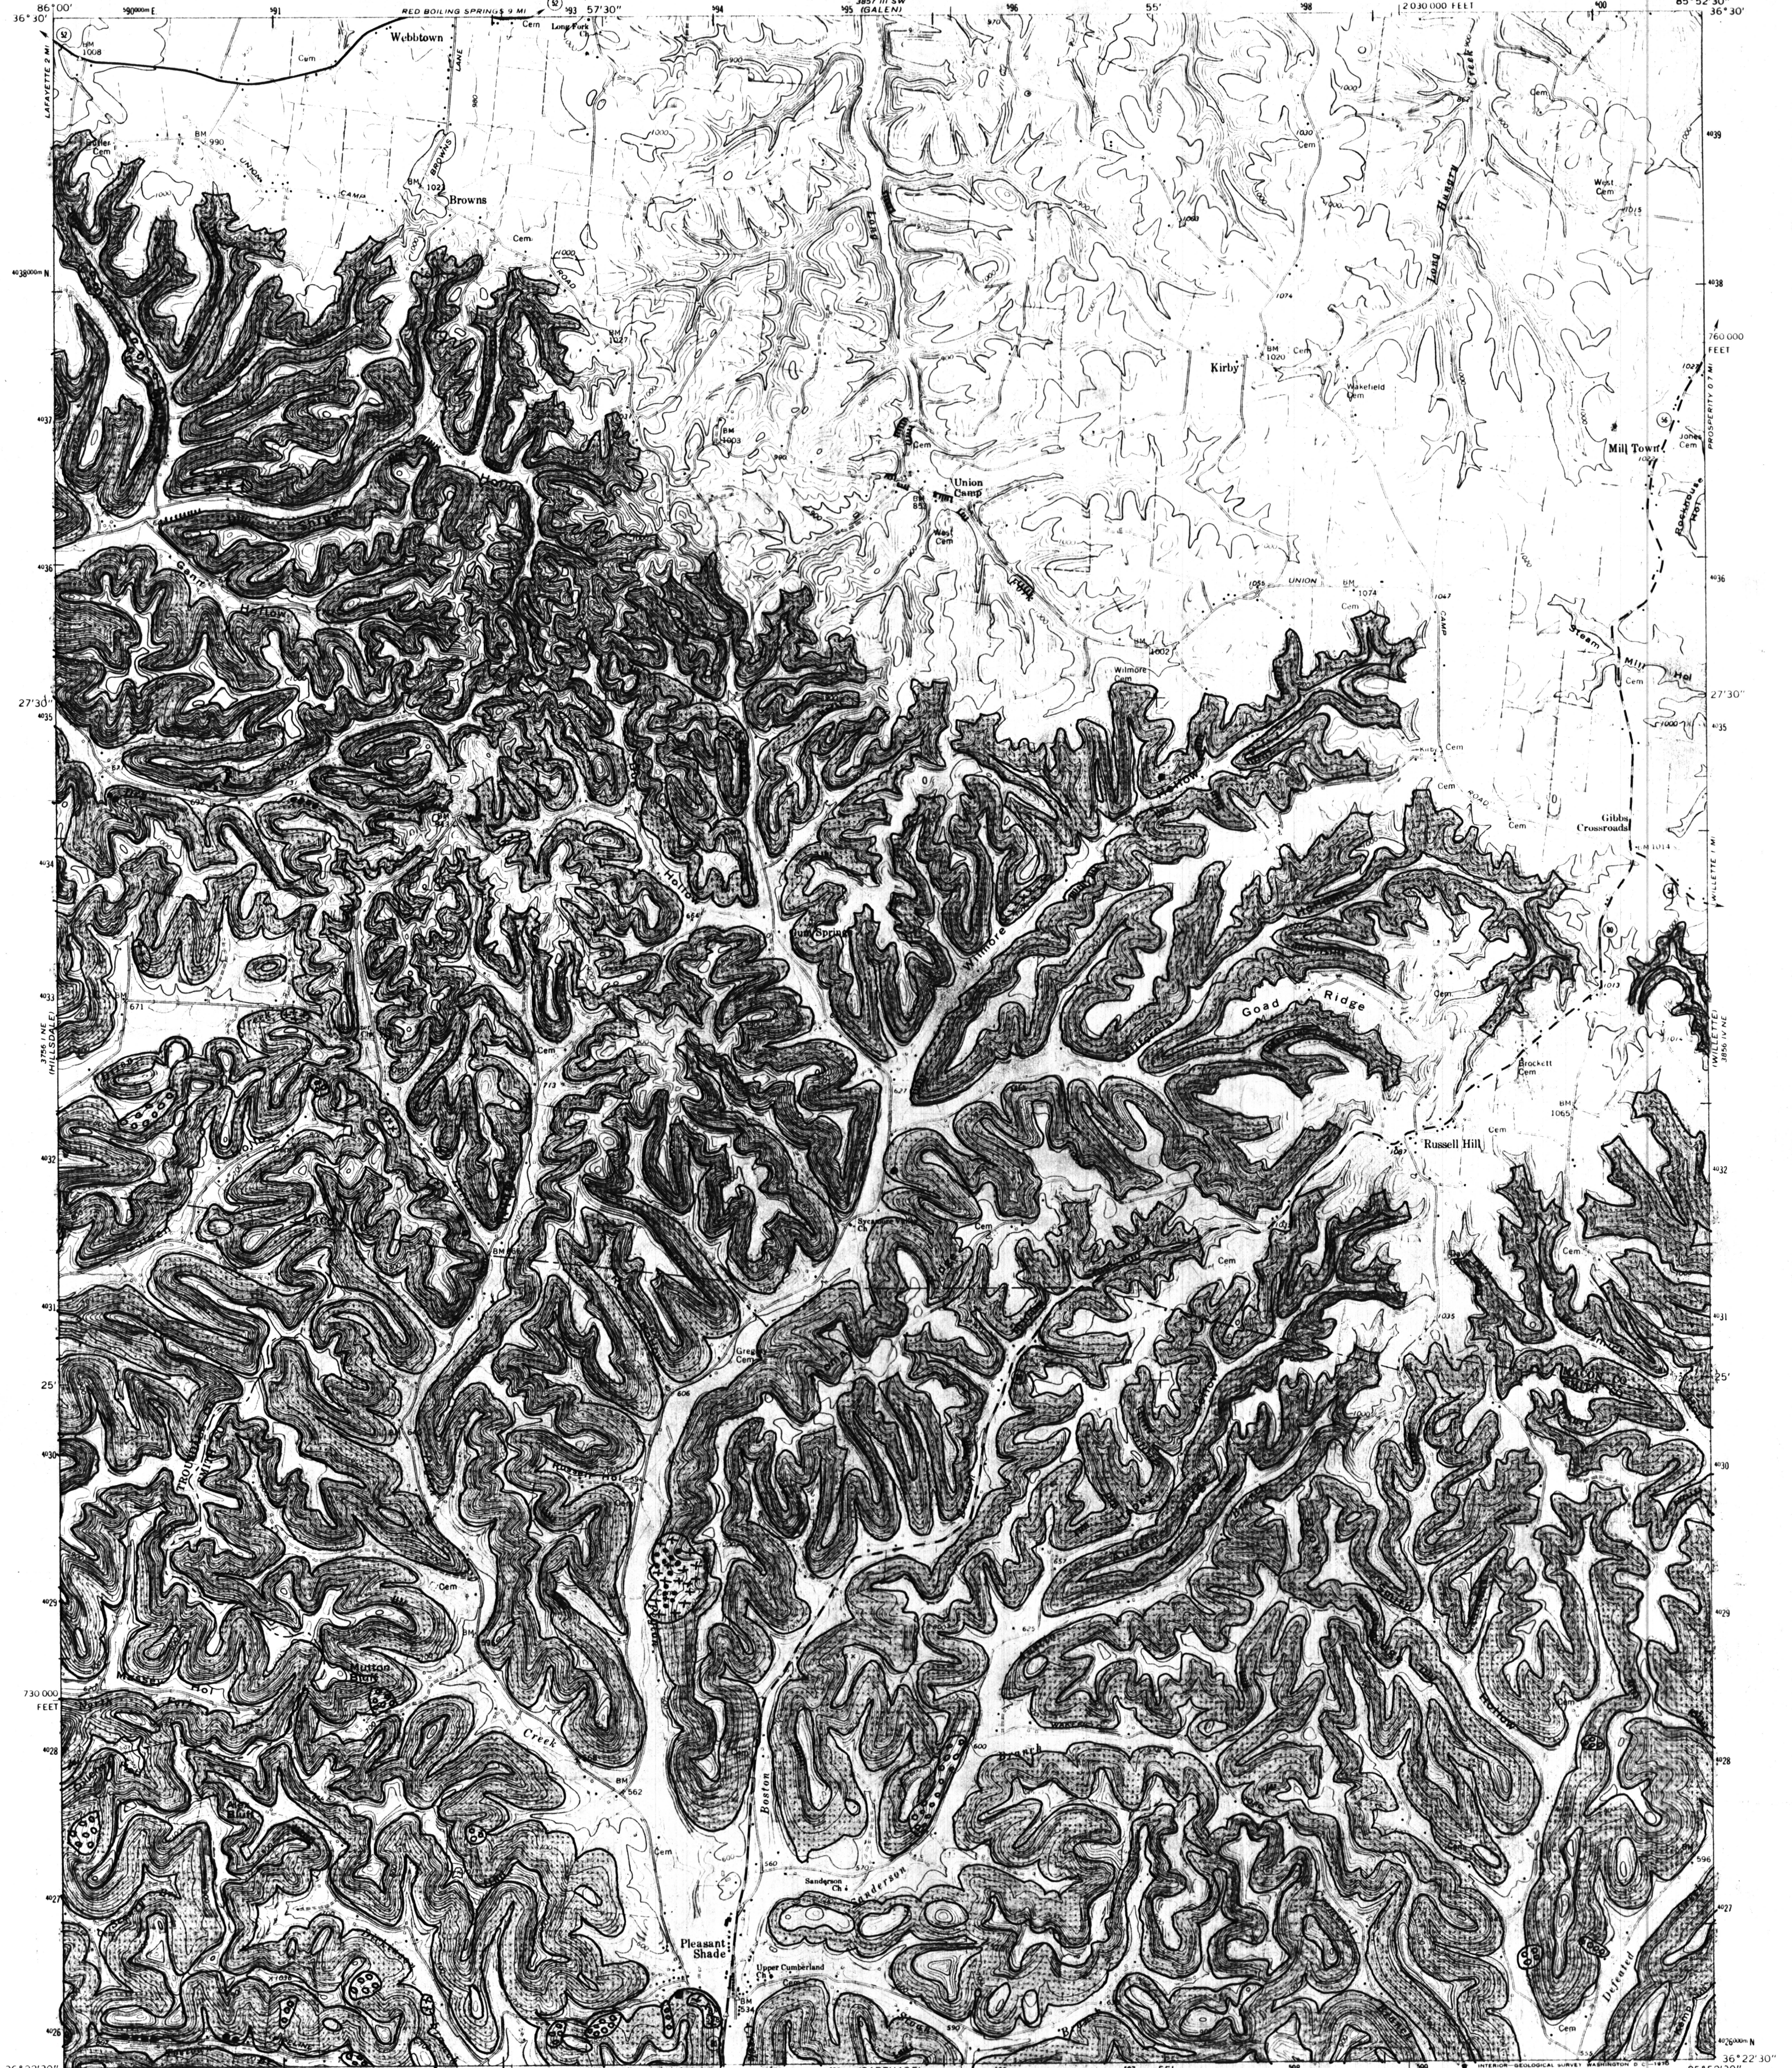
PLEASANT SHADE, TENN.
NW 1/4 CARTHAGE 15 QUADRANGLE
N 3622.5 - W 8552.5 / 7.5
1968

Landslides and related features interpreted
from aerial photographs:

ACTIVE OR RECENTLY ACTIVE LANDSLIDE
Complex landslide composed of earthflow, debris
slide, earth and rock slump. Identified from
historical records, and from scars, debris and
other field evidence. Ground extremely unstable;
sliding accelerated by excavation, loading and
changes in drainage conditions. May include
areas with several active slides too small to
be shown separately. Questioned where doubtful.

OLD LANDSLIDE
Area of extensive hummocky ground caused by
earthflow and earth and rock slump. Lacks
clear evidence of active sliding. Relatively
stable in natural, undisturbed state,
generally not affected by small structures properly
sited in areas away from the edge of the toe;
can be reactivated by extensive, rapid exca-
vation, loading, and changes in ground water and
surface water conditions. Area of old landslide
probably includes recent ones not identified
from field evidence or otherwise documented.
Upslope boundary of landslide generally defined
by modified scarp, but downslope (toe) may be
gradational and not well defined. Questioned
where doubtful.

COLLUVIAL SLOPE
Valley wall along major streams with slope as
steep as 40° (85%); stony, clayey silt soil up
to 50 ft. (15 m) thick; commonly buttressed by
a terrace or bench at the toe of the slope; very
susceptible to sliding by cutting of toe area,
removal of terrace or bench, and overloading;
slide commonly activated without apparent cause.

**AREAS SUSCEPTIBLE TO DEBRIS FLOWS AND DEBRIS
AVALANCHES**
Primarily shallow, narrow ravines and chutes with
accumulation of stony colluvium generally 10 ft.
(3 m) or less in thickness; susceptible to rapid
movement during intense rainfall. Most ravines
and chutes designated show evidence of former
debris flows and avalanches.

AREAS SUSCEPTIBLE TO ROCKFALL
Steep, locally vertical, natural and man-made
slopes and cliffs, 15 ft. (4.5 m) or more high;
formed dominantly of sandstone, limestone, sandy
shale, mudstone and claystone. Interbedded mud-
stone, claystone and shale weather rapidly leaving
sandstone and limestone rock faces unsupported.

SOIL AND ROCK SUSCEPTIBLE TO LANDSLIDING
Soil and rock similar to that involved in land-
slides elsewhere in map area; primarily areas
underlain by claystone, mudstone and shale
associated with other rock types. Rock weathers
rapidly on exposure forming clayey soil highly
susceptible to sliding. Includes coves (U-shaped,
shallow valleys) containing thick layers of clayey
soil that are very susceptible to sliding where
excavation breaks continuity of slope and where
overloaded by artificial fill.

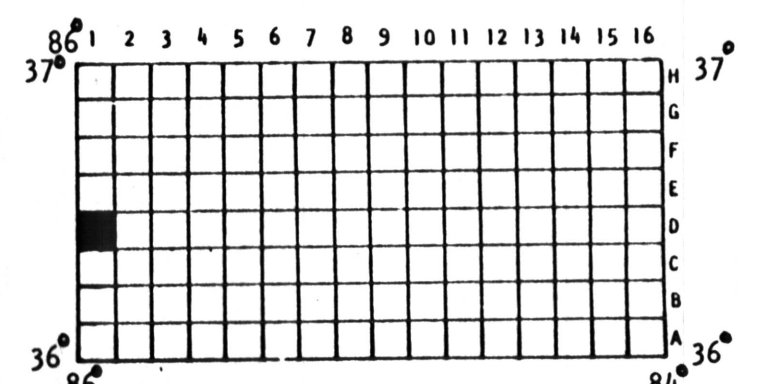
The first five digits of the open file number designate the
specific 1:250,000 scale map sheet of which this quadrangle
is a part. The last two digits designate the position of the
quadrangle in a subdivision of the 1:250,000 scale map based
on rows and tiers shown in the diagram to the right. The
location of this quadrangle is shown by the black square.
